Technical Service Bulletin

91 Parking assistance provides false warnings

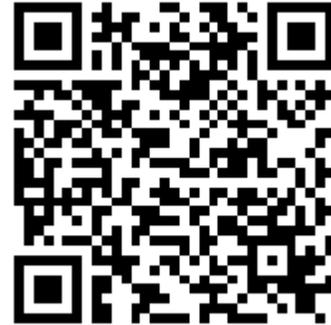
Figure 1. False parking system warnings.

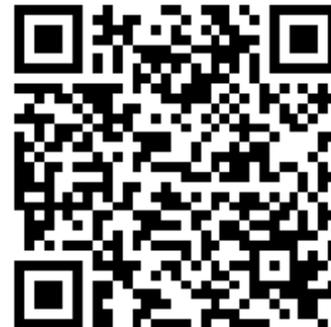
Figure 2. Parking system malfunctions.

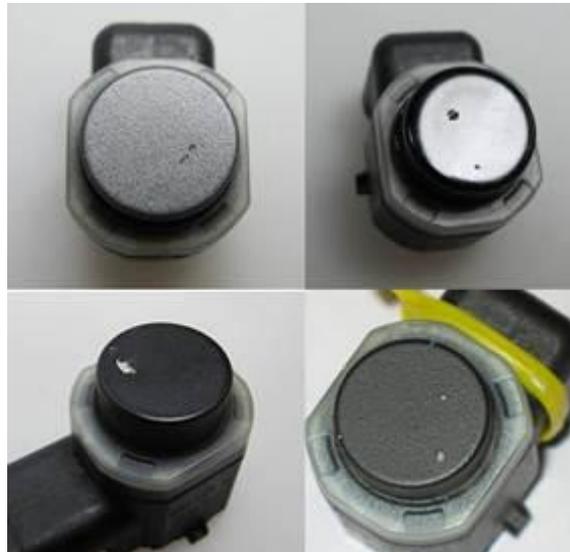
• **Figure 3.** Stone chips causing sensor failure.

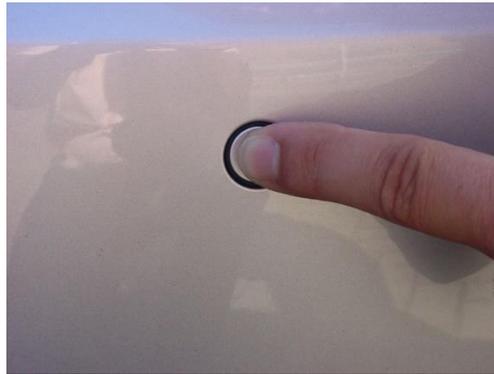
Figure 4. A pressure check on a parking aid sensor.

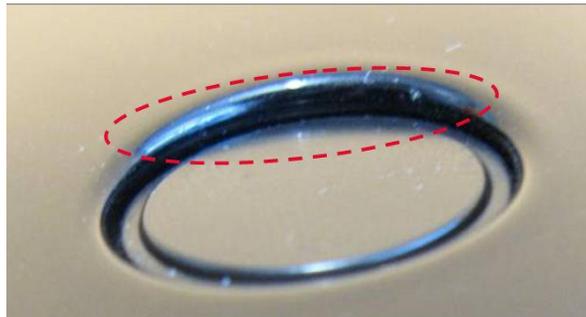
Figure 11. A recessed parking aid sensor.

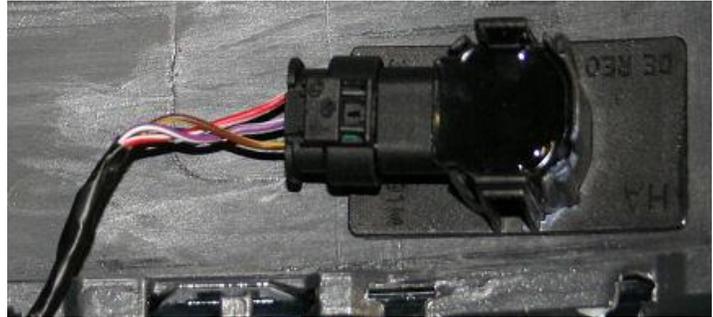
Figure 12. A correctly installed cable with sufficient length.
